Technical Preservation Services
Preservation Assistance Division
National Park Service
U.S. Department of the Interior
Washington, D.C.

Interpreting the Secretary of the Interior's Standards for Rehabilitation

Volume III

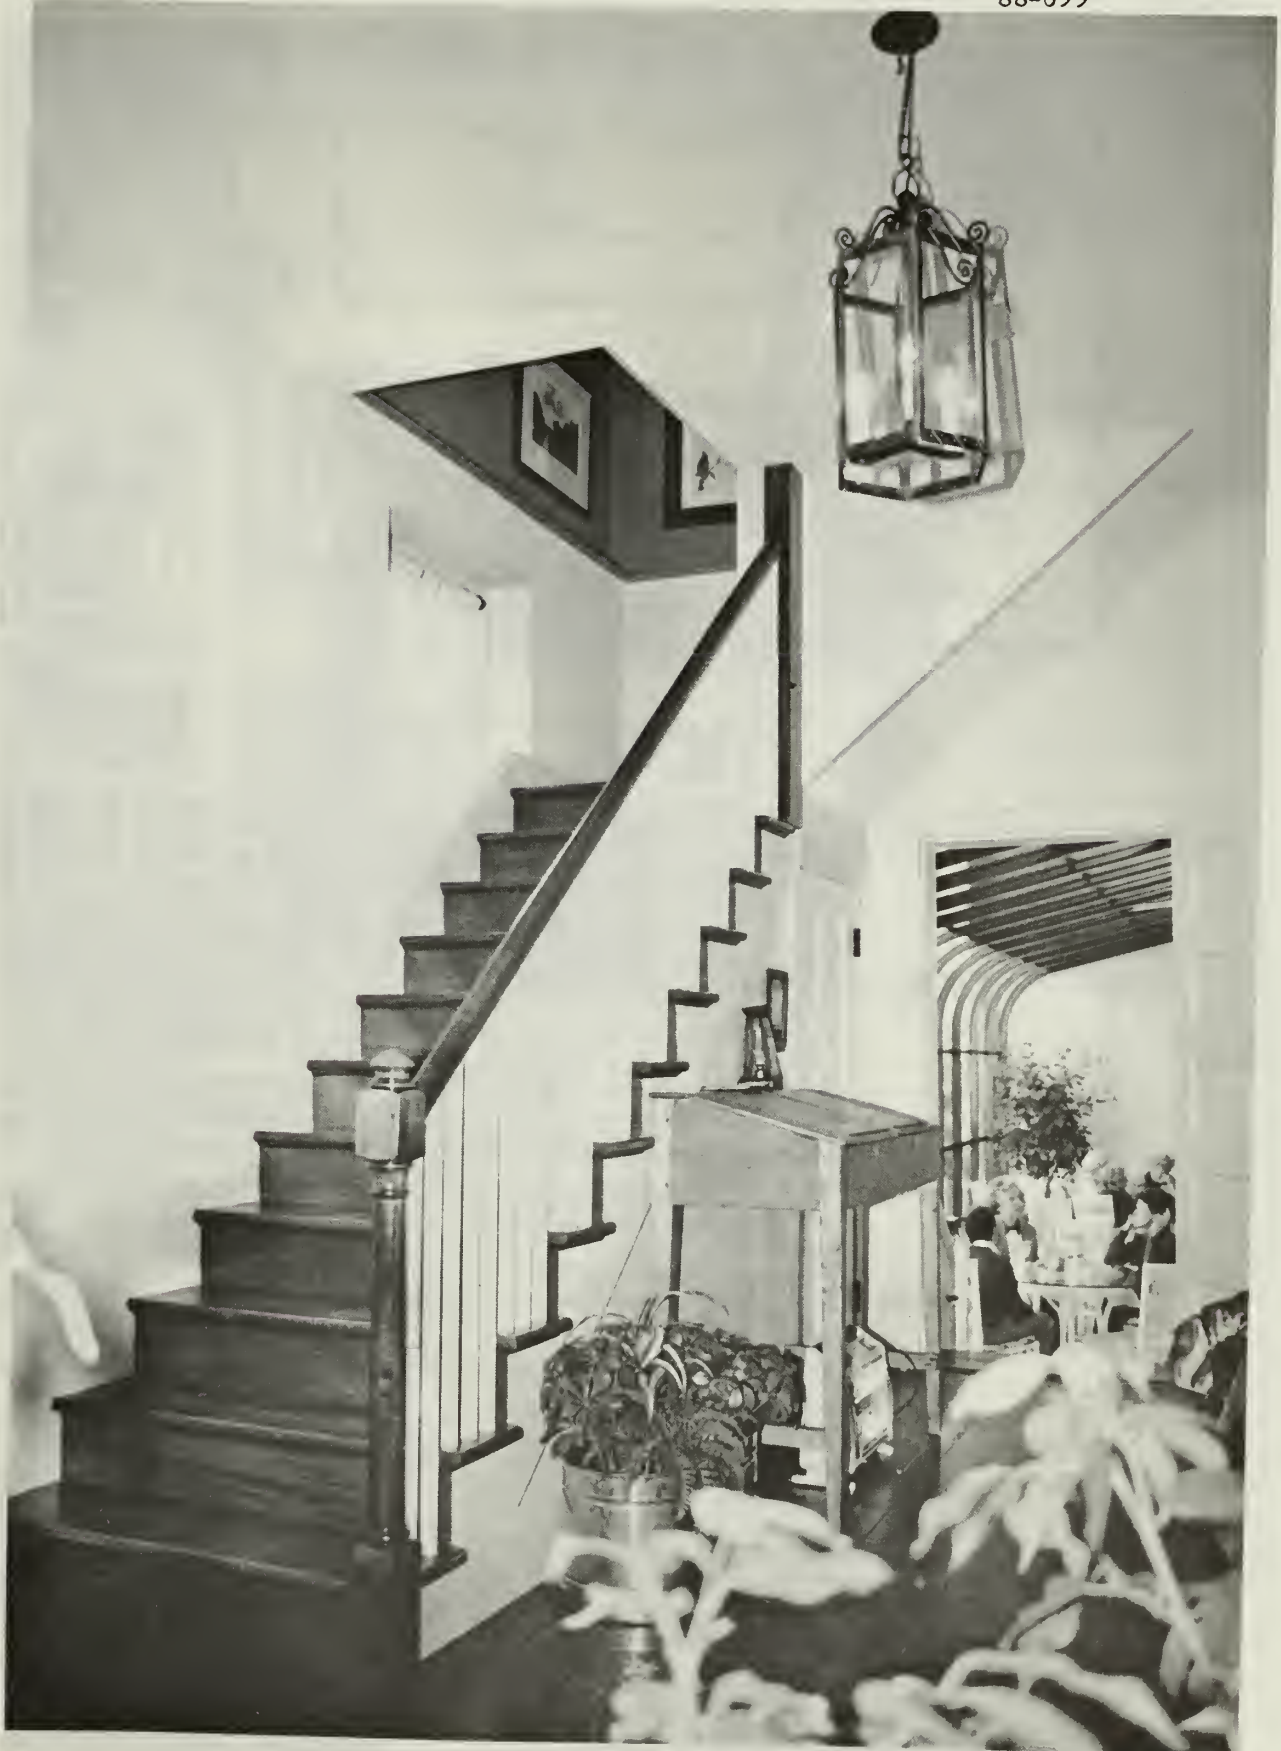
3. New stair after rehabilitation. Design of stair was not based on historic evidence.

1839 and 1870. The ca. 1870 porch, however, was retained and preserved, as was the ca. 1912 rear ell addition. Although the new stair was based on scattered ghost marks and fragments of the original stair, there was no evidence of what the original bannister and newel post looked like, and as a result the new appearance is conjectural (see illus. 3). Also conjectural is the design of the new front door which was installed to replace two ca. 1912 doors. The only evidence existing for the front door was three hinges found near the suspected location of the original door.

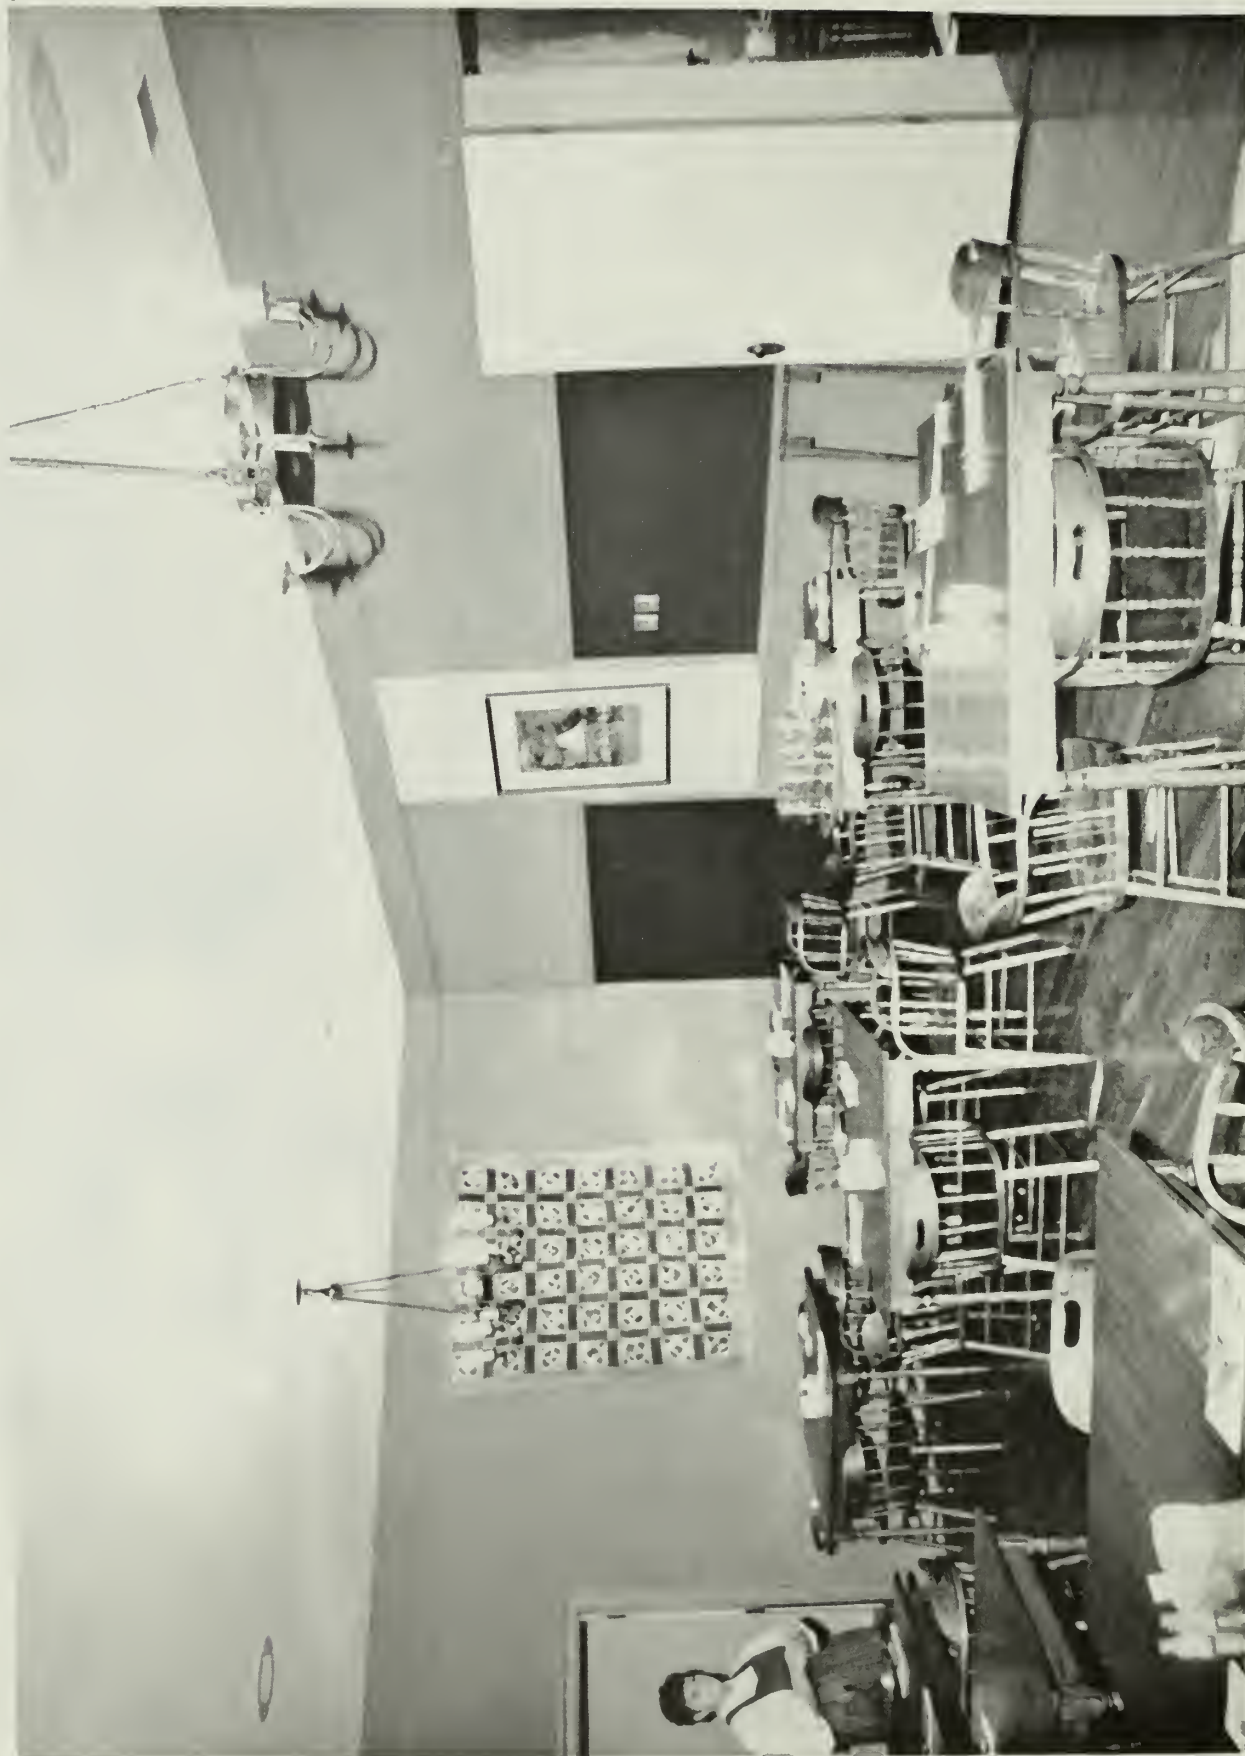
4. Main dining room in first floor of restaurant after rehabilitation. Note ca. 1912 door and molding remain, and ca. 1839 window

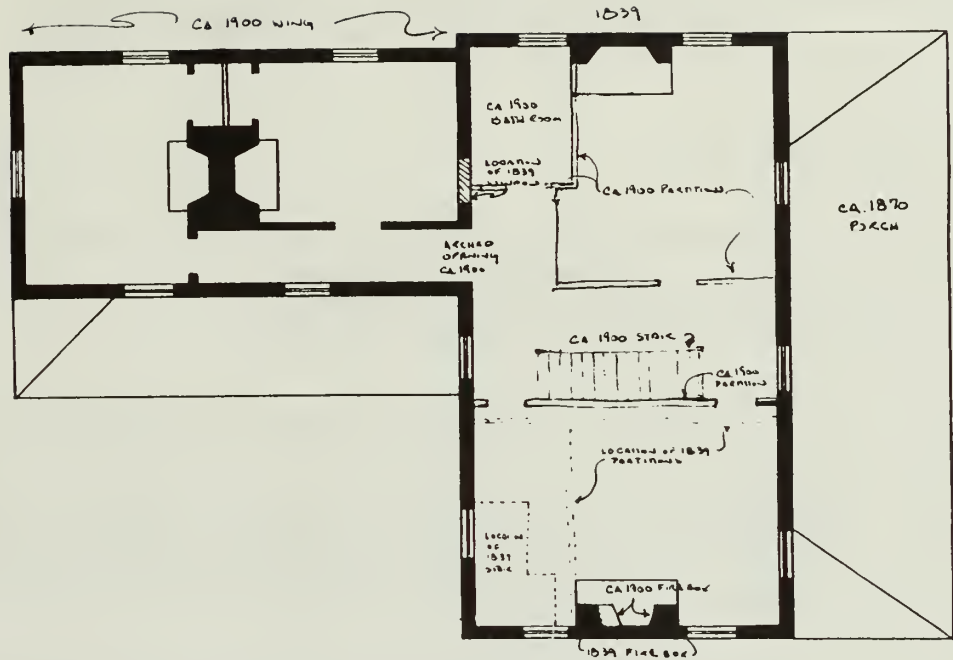
5. Second floor plan prior to rehabilitation.

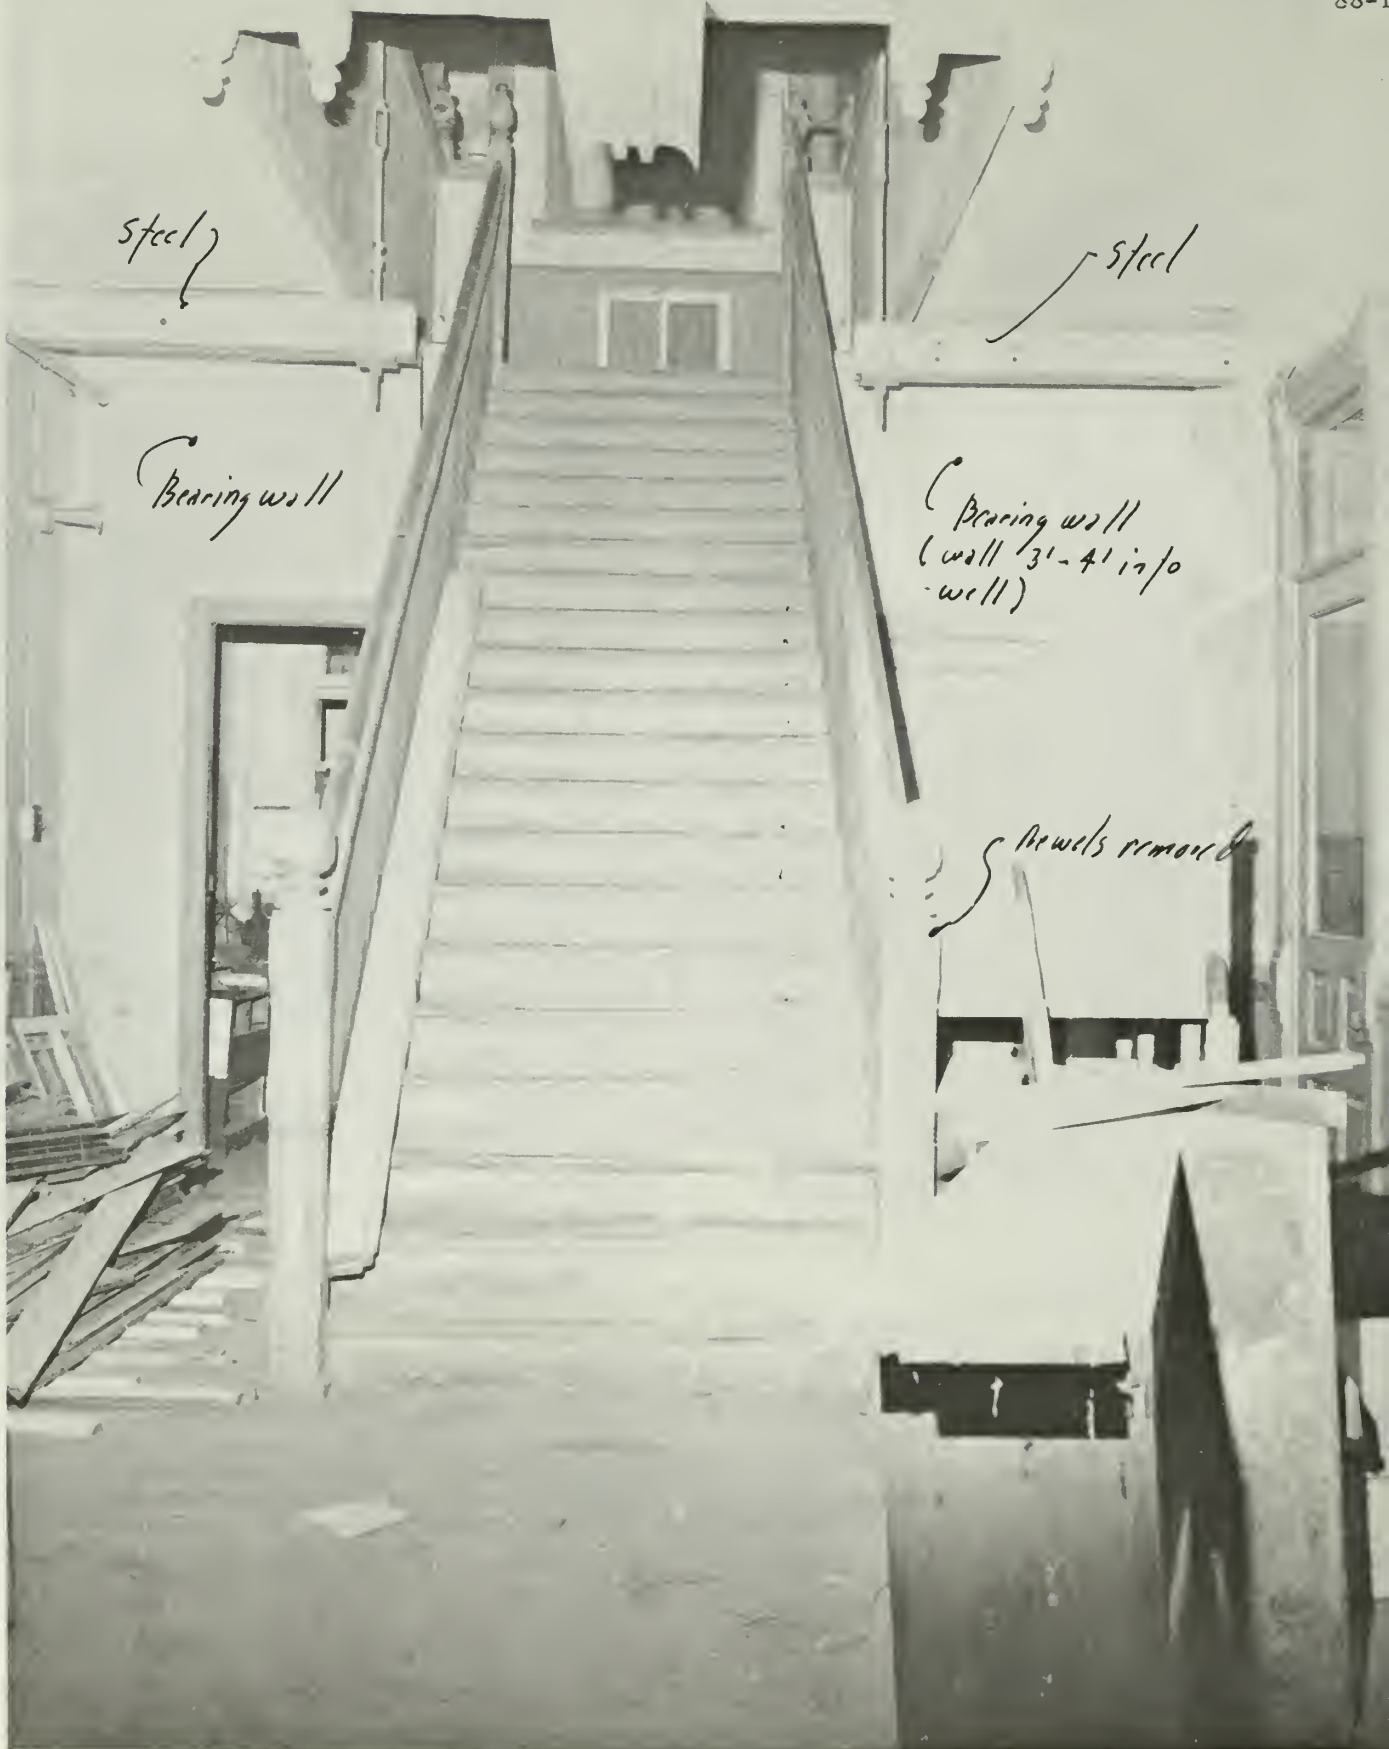
2. Pre-rehabilitation photograph of first floor center stair and hall. This stair was removed in the process of rehabilitation.

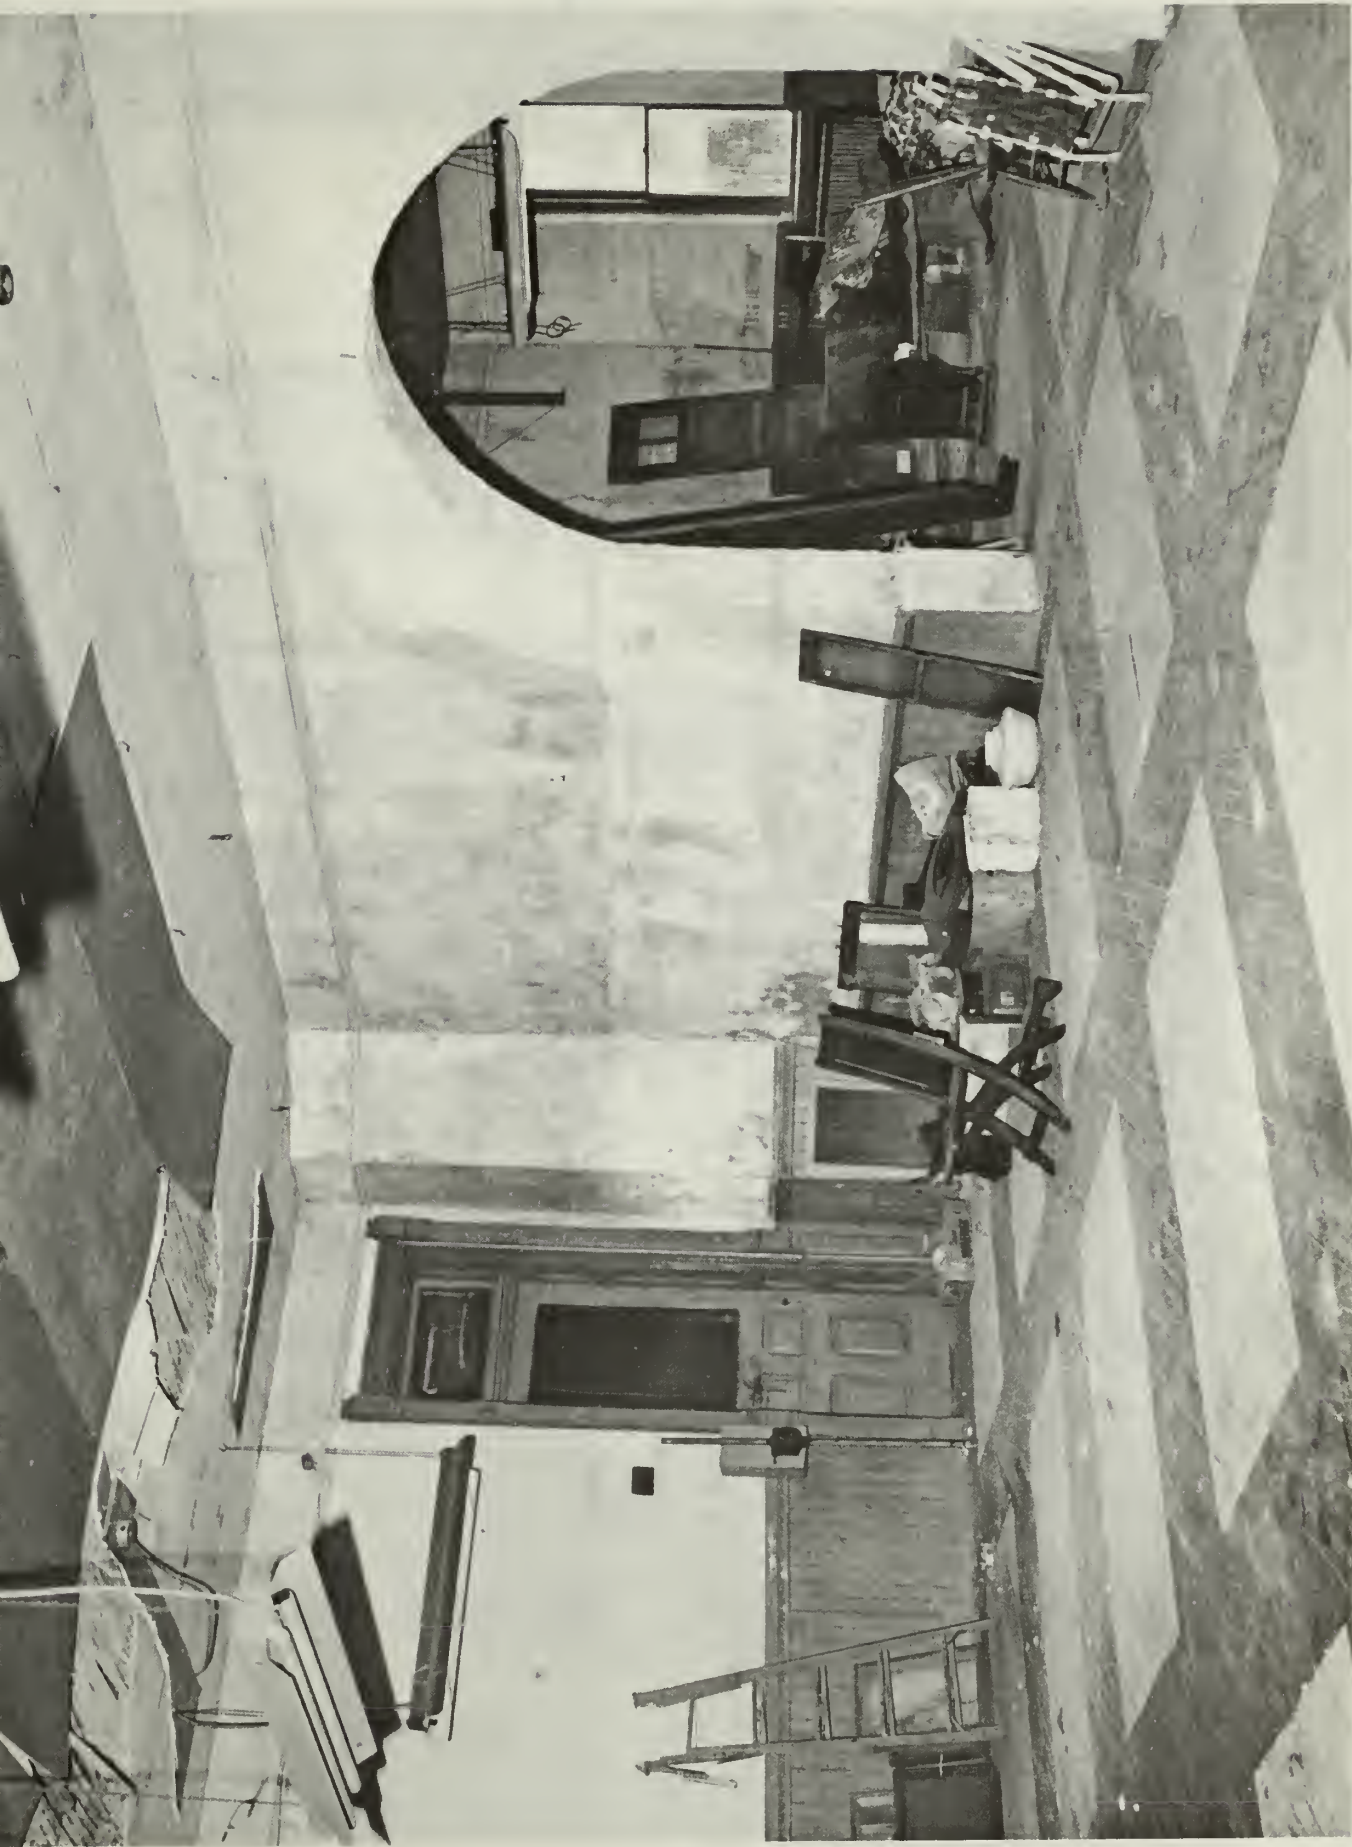
3. View of interior first floor classroom prior to rehabilitation. Arched opening between classrooms was added after original construction.

Another distinctive feature that was characteristic to this building type was the panelled wainscotting found throughout the interior. However in the rehabilitation, the interior face of the exterior walls was furred out and significant amounts of wainscotting were subsequently covered (see illus. 6). This treatment has caused the wainscotting to appear fragmented and dis-continuous. The remaining wainscotting appears to be randomly placed, and together with the significant subdivision of the classrooms prevents a clear understanding of the original classrooms' design and space.

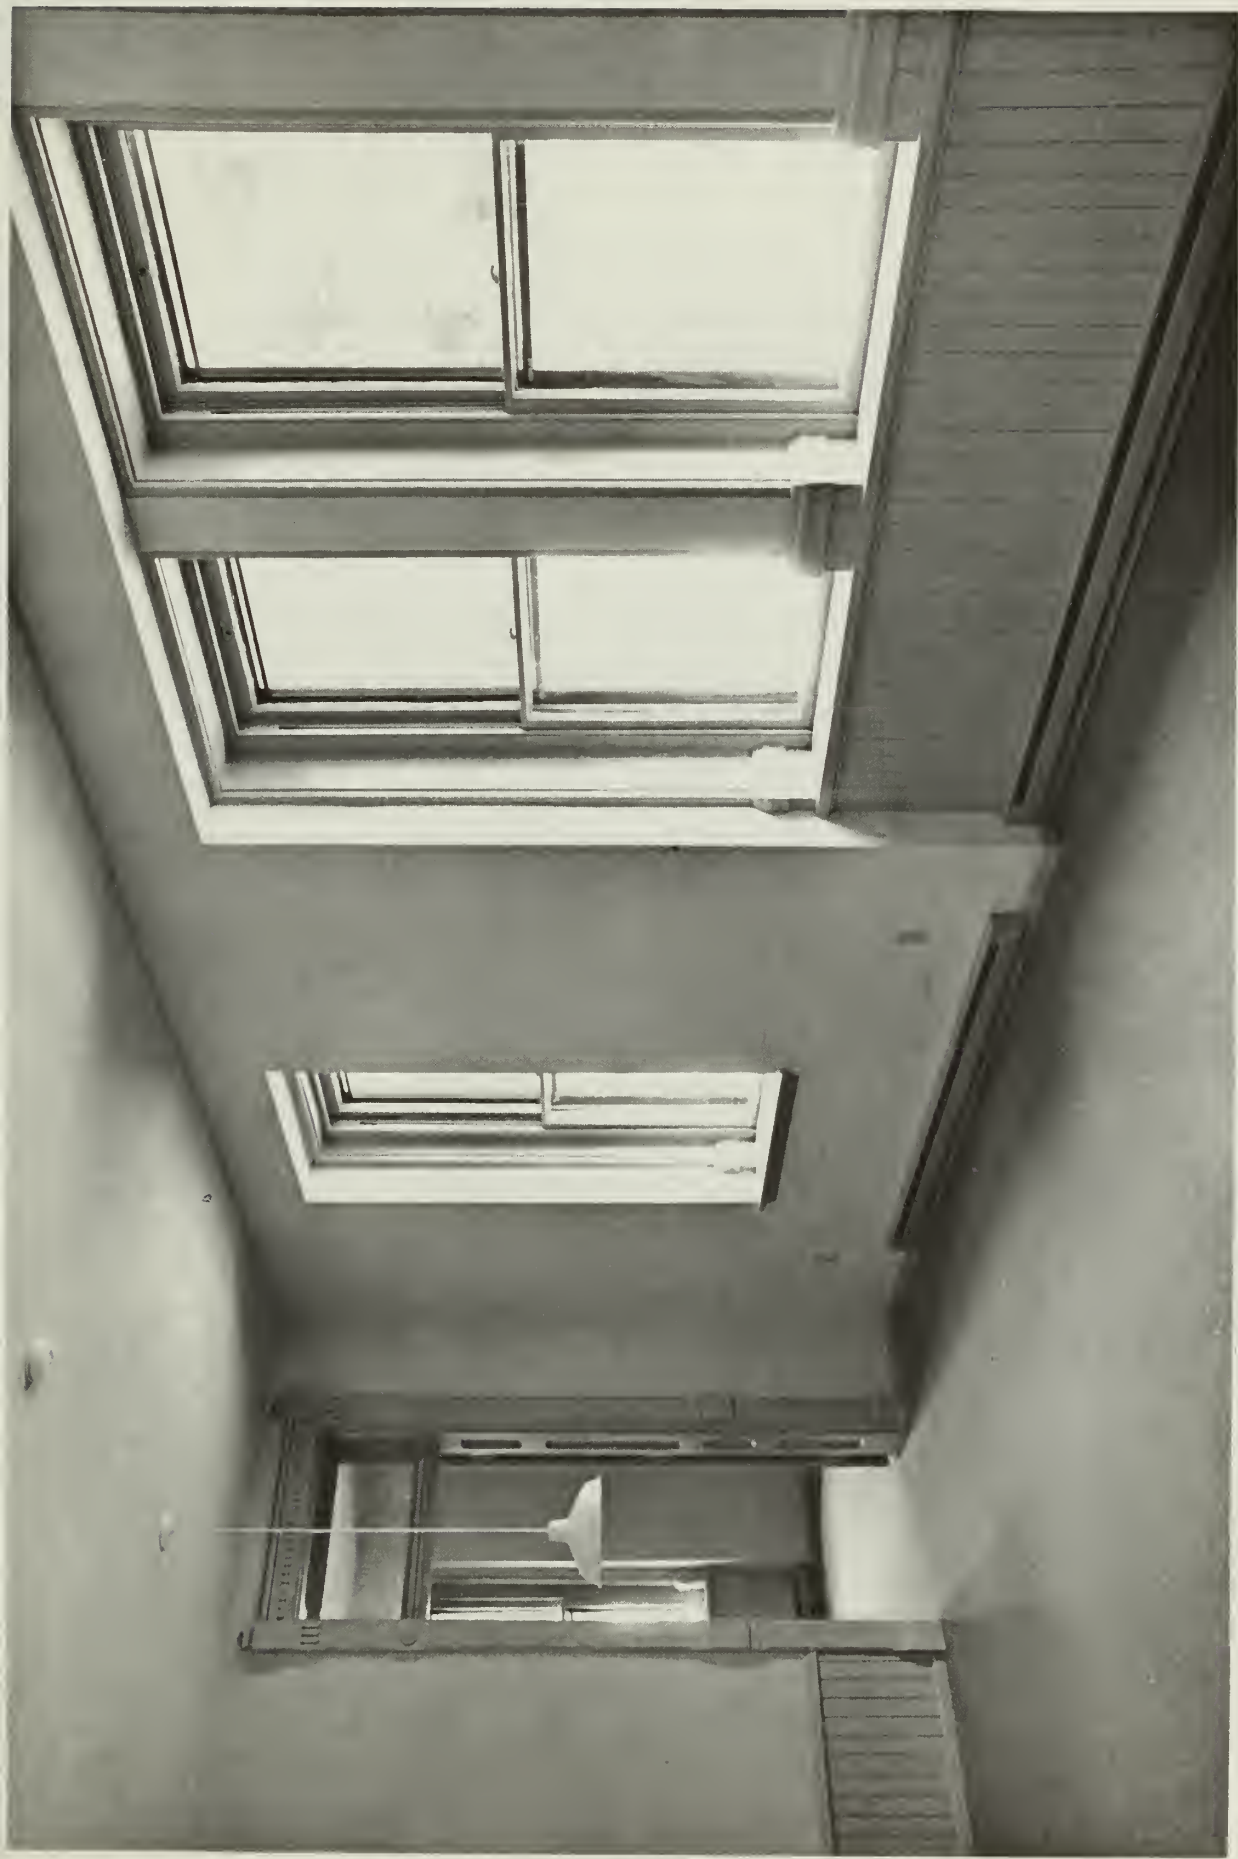
6. Third floor classroom as modified for apartments in rehabilitation.

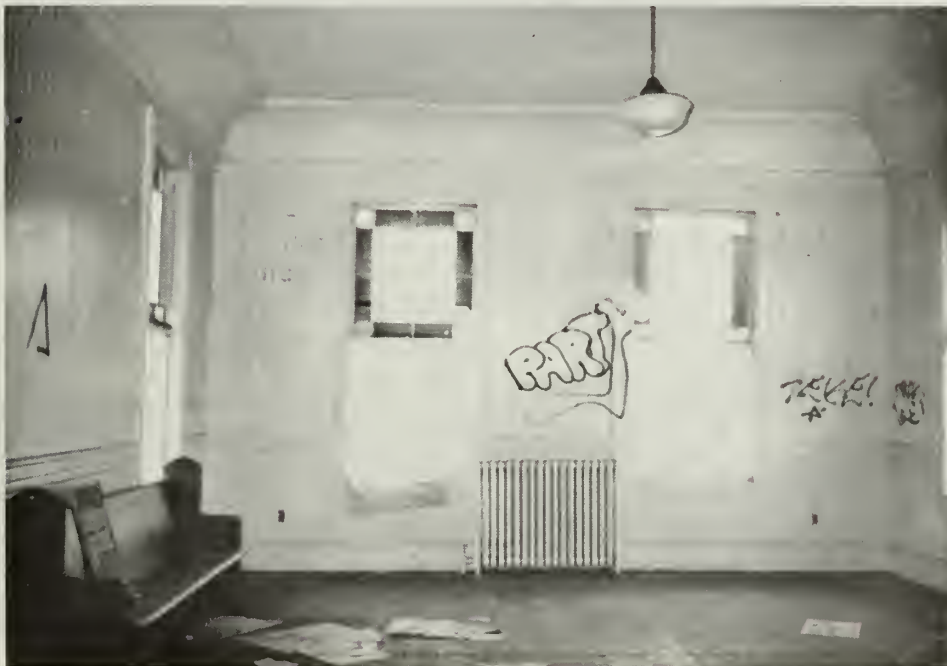
2. Interior view of waiting room prior to rehabilitation. Note wooden ceiling and wide covered cornice.

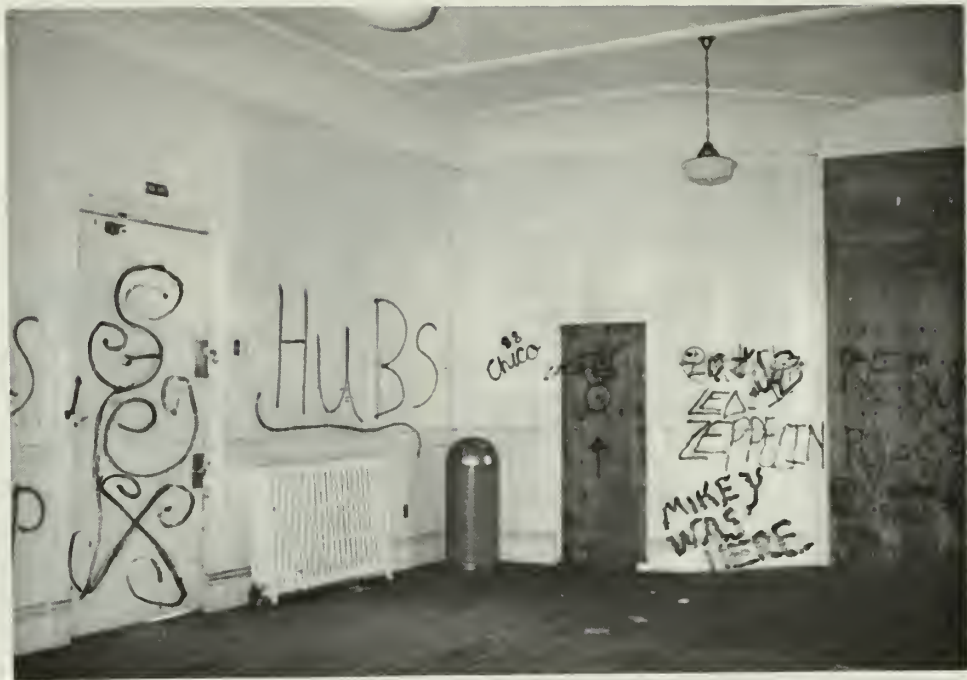
3. Interior view of ticket booth prior to rehabilitation. This historic feature was removed in the process of rehabilitation.

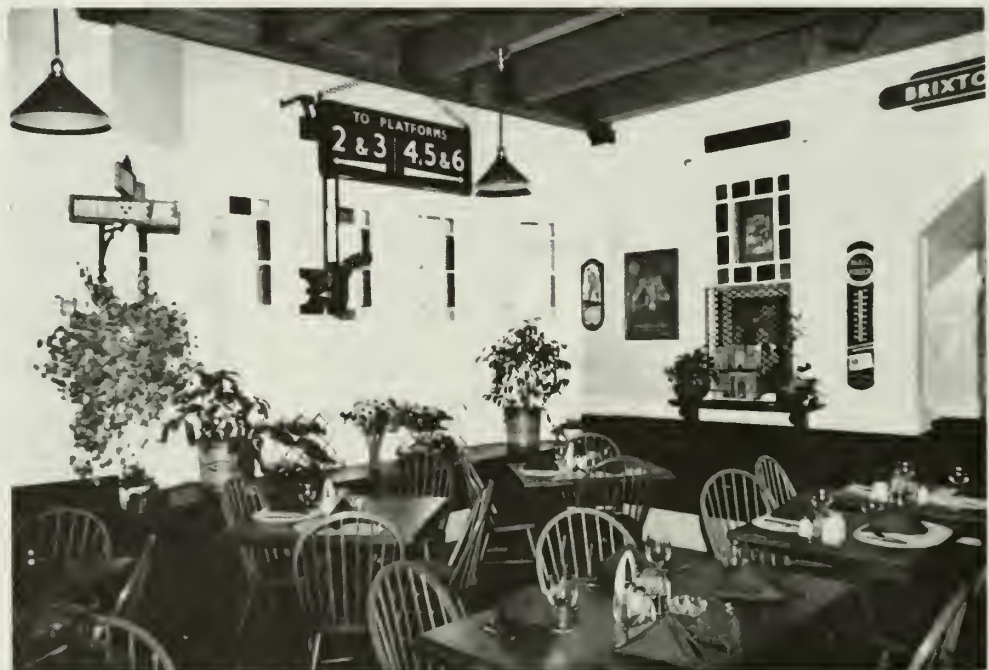
4. Post-rehabilitation view of waiting room after the removal of ticket booth. Note ticket booth window relocated in new stair wall.

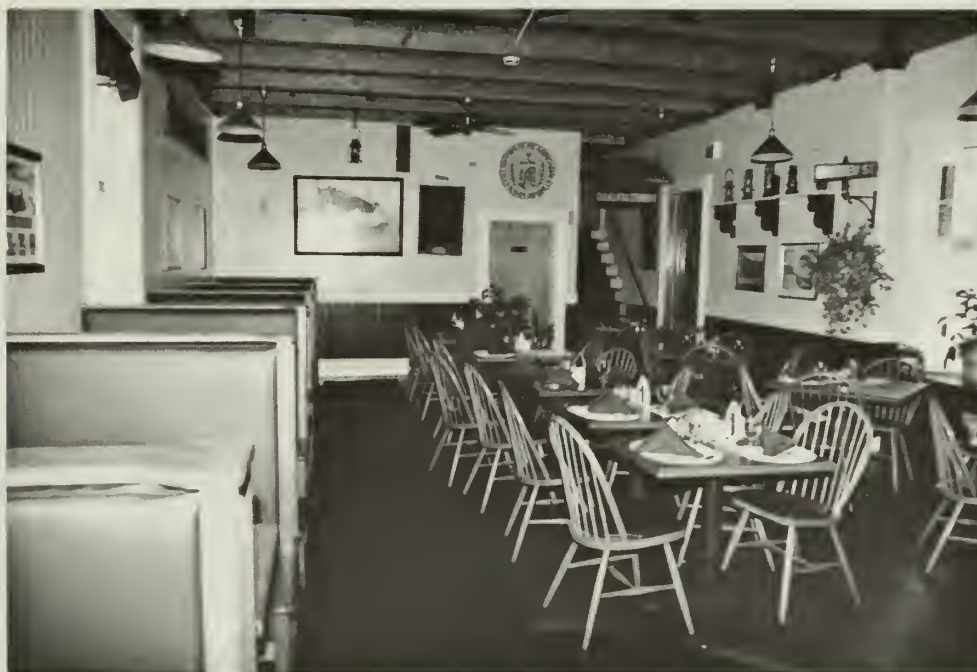
5. Post-rehabilitation view of waiting room. Note the removal of existing ceiling, and the addition of exposed ceiling joists above.

The ceiling of the depot which was removed to install a functional second floor above, was replaced with new ceiling joists dropped below the original first floor ceiling (see illus. 5 & 6). The new unfinished and exposed wood joists are not in keeping with the character of the previously finished waiting room. Further compromising the room was the insertion of restrooms and a staircase at one end of the waiting room; two end windows were obliterated and the distinctive waiting room was reduced by approximately 1/4 to 1/3. Although some detailing was retained on the interior, it was extensively reconfigured, and the new features added were incompatible to the building. As a result, the existing 19th century interior lost its integrity and historic character.

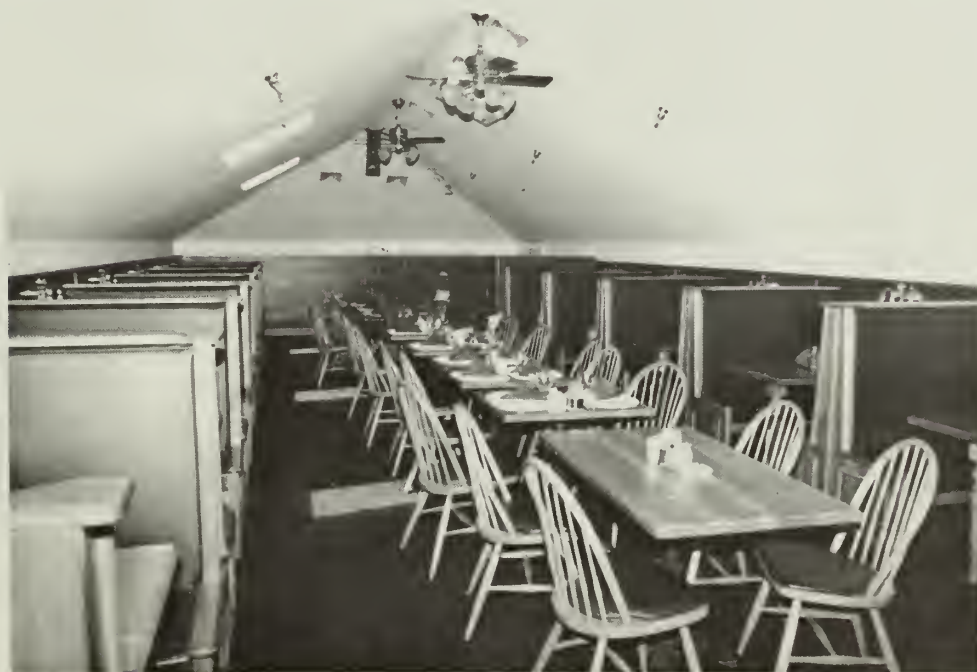
6. Post-rehabilitation view of second floor. Original attic space converted to restaurant space by lowering the ceiling below.

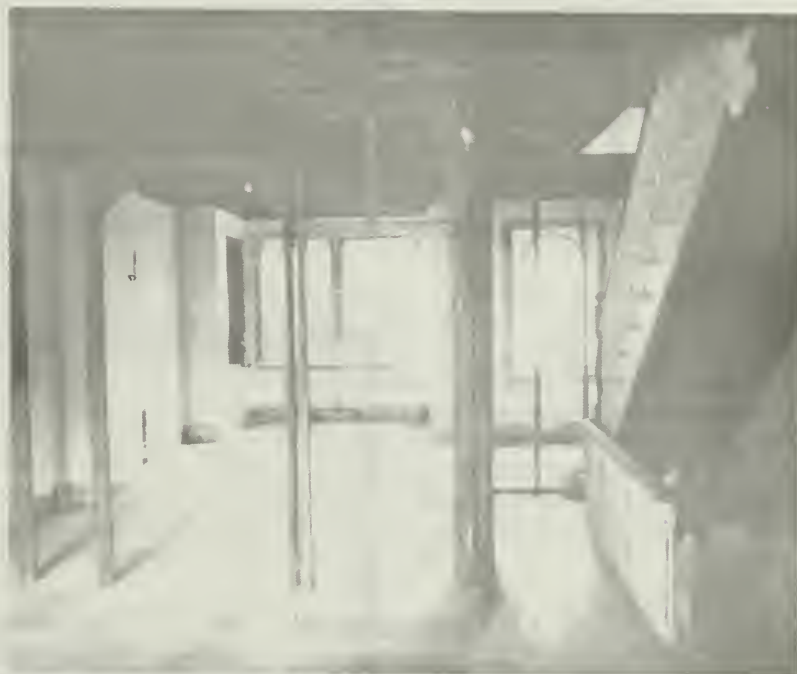
2. The interior of the house after it had been "gutted" by the previous owner. The photographs of all 3 floors are taken from the same location on each floor, and show views toward the front of the house. The new owner was able to repair and reuse wood trim (here, shown piled behind the stairs on the third floor), that had been removed by the previous owner.

Despite the existing shell-like condition of most of the interior, the new owner restored the historic staircase (although code compliance necessitated several changes) and repaired and reused the woodwork and trim that had been removed by the previous owner. Because the rehabilitation also included a careful restoration of the exterior, which was the major remaining character-defining aspect of the building through which it contributed to the significance of the historic district, the rehabilitation was certified.

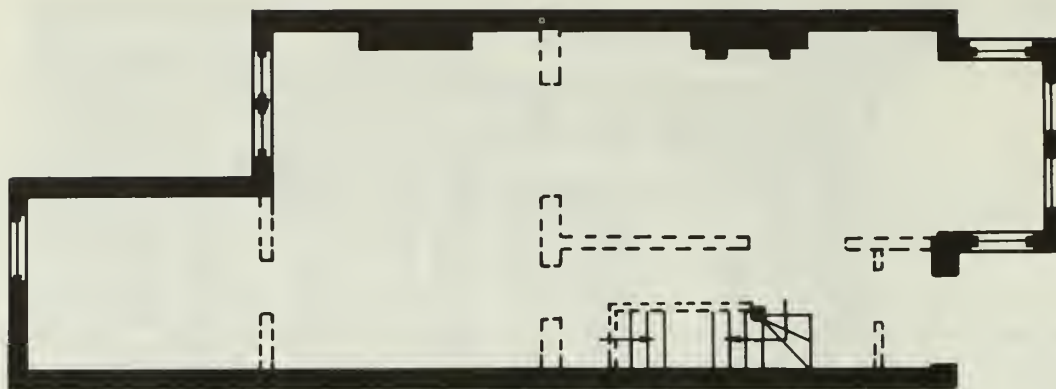
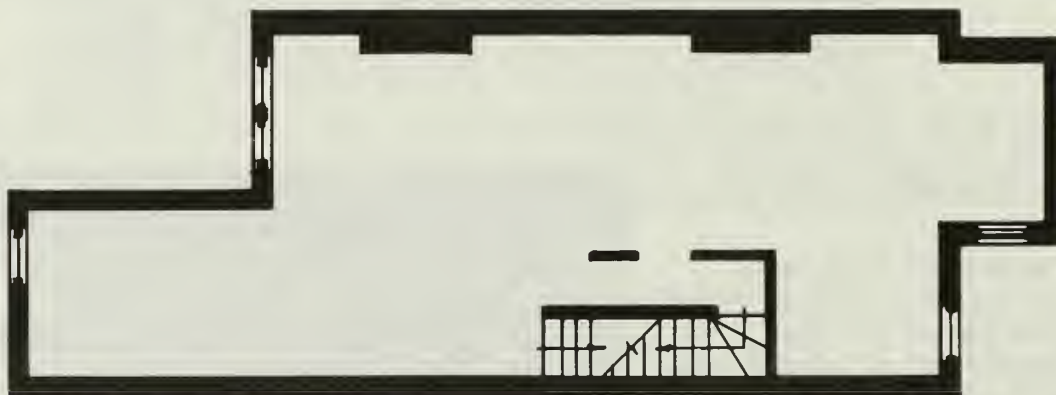
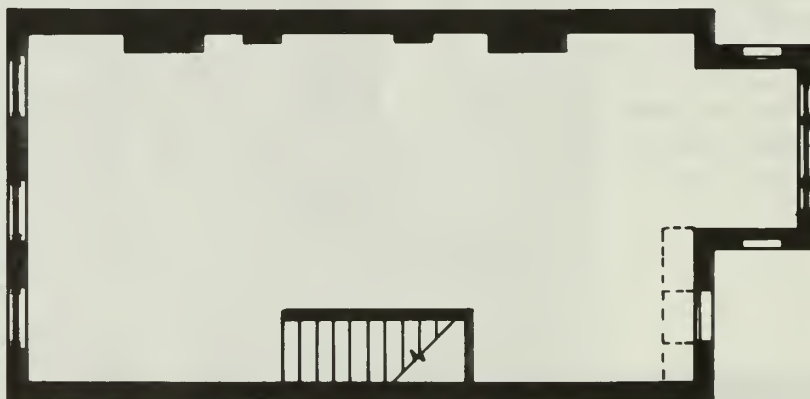
3. Floor plans of the interior prior to rehabilitation. The fireplaces had been removed during previous renovations. Dashed lines represent open stud walls.

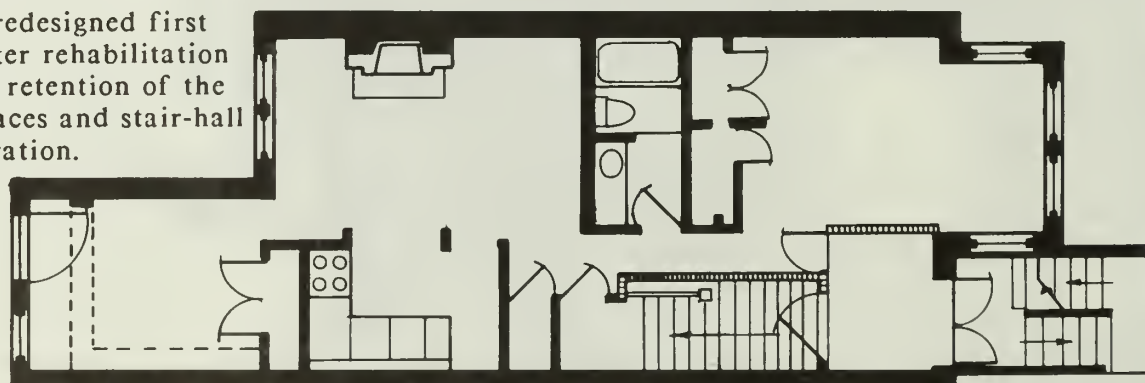
FIRST FLOOR REHABILITATION

4. The redesigned first floor after rehabilitation showing retention of the basic spaces and stair-hall configuration.

generally not a recommended rehabilitation treatment, in this case it was minimally acceptable because it did not destroy an original or historic spatial sequence. That had already been lost when the previous owner removed the walls which had traditionally defined these spaces.

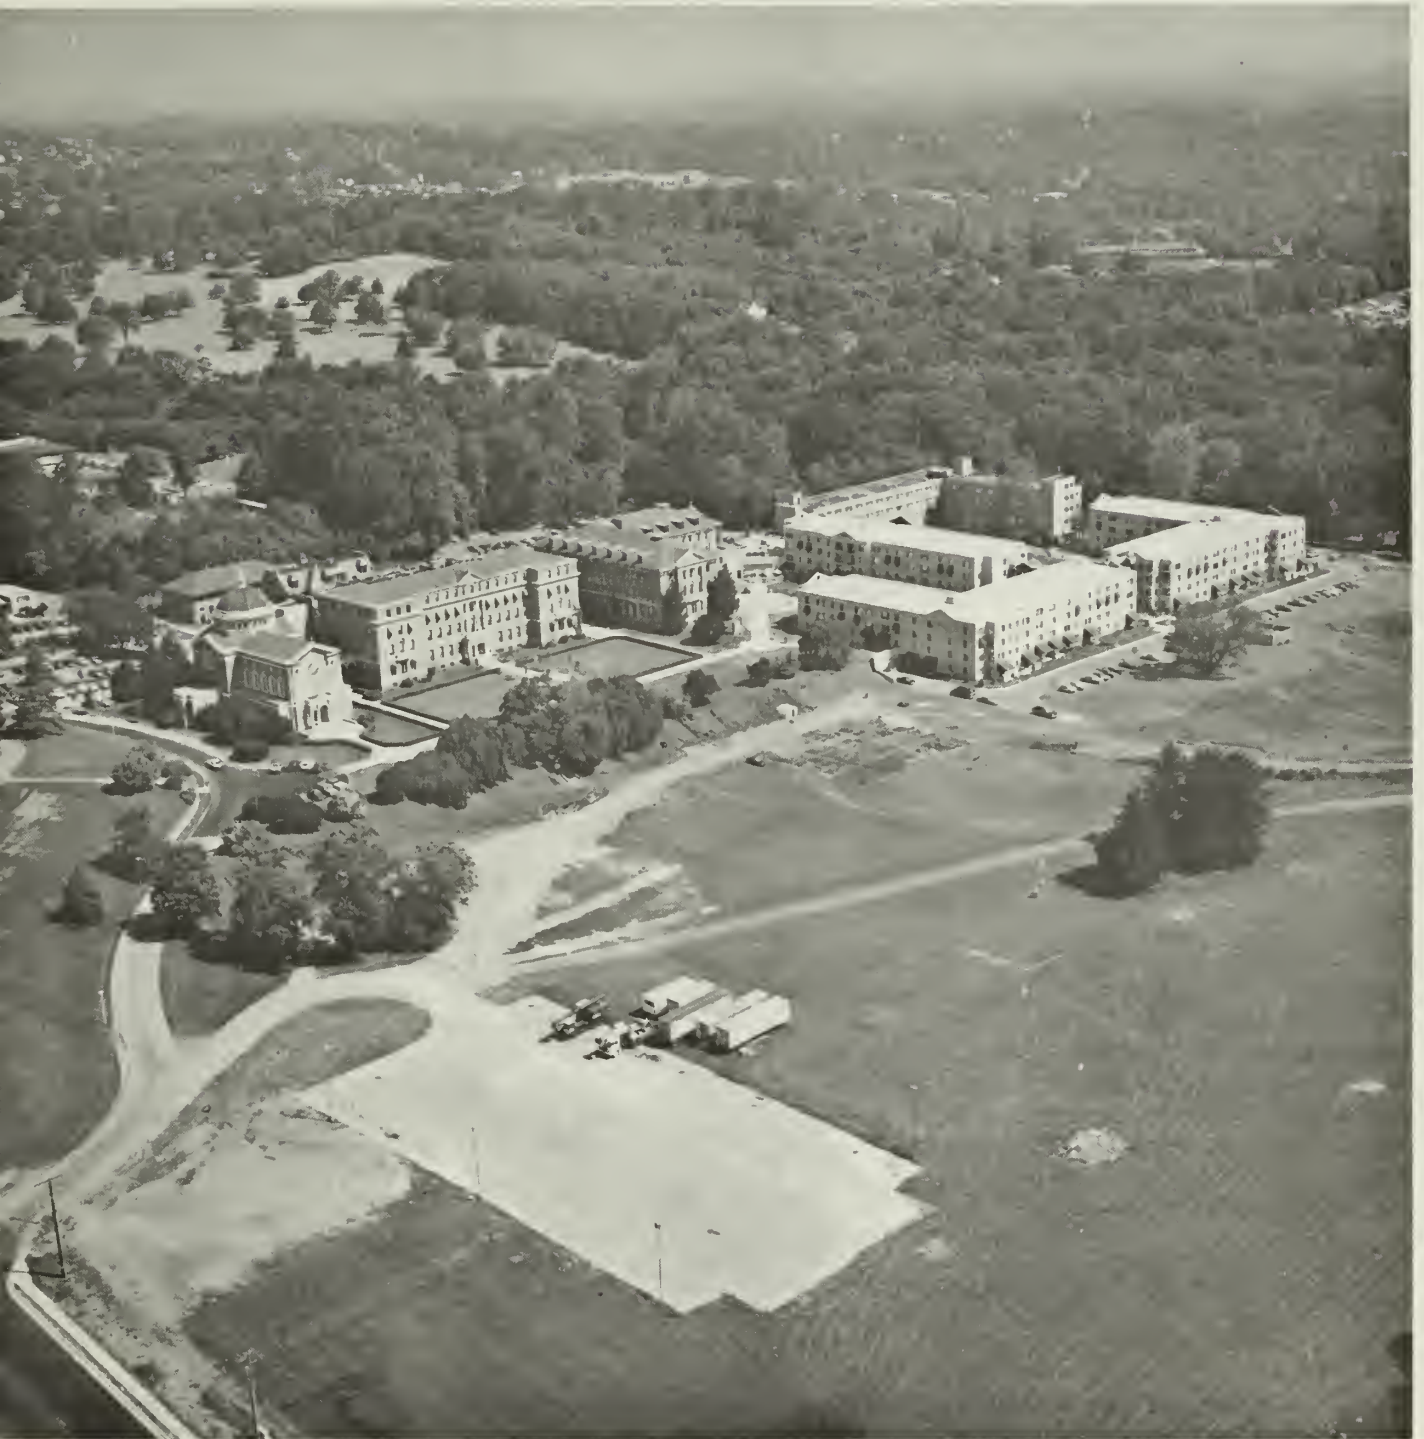
2. Aerial view of campus. The three new buildings at right visually sever the end building from the rest of the row, thereby drastically diminishing its historic character.

Although the new construction is generally sympathetic to the neighboring historic buildings in size, scale, color, materials, and design, it fails to meet Standards 2 and 9 of the Standards for Rehabilitation because of its impact on the site and environment of the building it obscures.

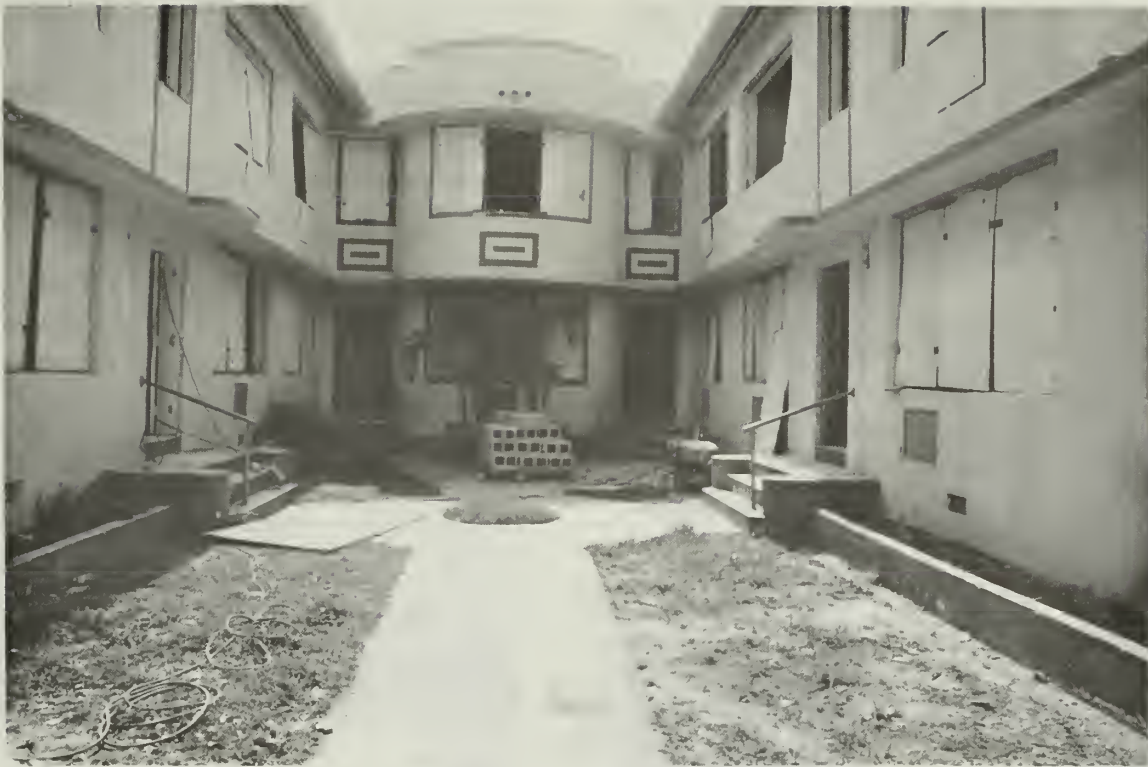
1. The primary entrances to this early 1940s Moderne apartment building are located in the courtyard of the U-shaped structure. Note the overall plainness of the building before rehabilitation, which is highlighted only by horizontal banding and raised geometric panels.

As part of the rehabilitation, the exterior stucco, which had been repaired and patched as necessary, was painted as the owner himself stated, in a "fanciful and sportive manner." Prior to rehabilitation, the building had been painted beige with a few of its decorative features highlighted in a darker brown. After rehabilitation, the wall surfaces of this building had been transformed by the application of numerous colors and decorative painted and patterned surfaces (see illus. 3-5). Wall surfaces were painted in alternating horizontal bands of aqua, yellow and pink, and projecting horizontal overhangs and the raised geometric panels were boldly outlined in black. Most notable was the use of paint to create contemporary stylized patterning, exaggerated illusionistic stone textures on door surrounds and above door panels, and a "cracked-tile" pattern above second-story stairwells and on planters surrounding the base of the building.
